WALLKILL RIVER BASIN
SAWMILL BROOK, SUSSEX COUNTY
NEW JERSEY

HEATERS POND DAM NJ 00795

PHASE 1 INSPECTION REPORT
NATIONAL DAM SAFETY PROGRAM

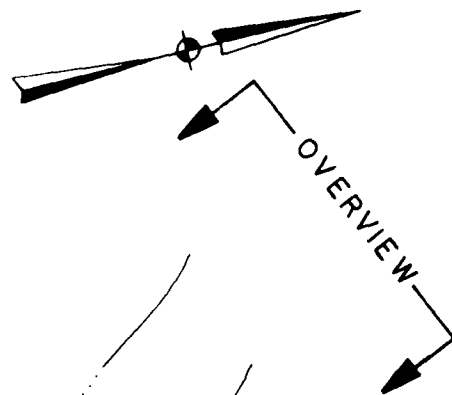
Standing water indicating possible seepage was observed at two locations at the toe of dam. Arrangements should be made in the near future to monitor the possible seepage in order to detect any changes in condition. The monitoring should be performed by a professional engineer experienced in the design and construction of dams.

Concrete
Spillway
Seepage

Arrangements should be made in the near future to monitor the possible seepage in order to detect any changes in condition. The monitoring should be performed by a professional engineer experienced in the design and construction of dams.

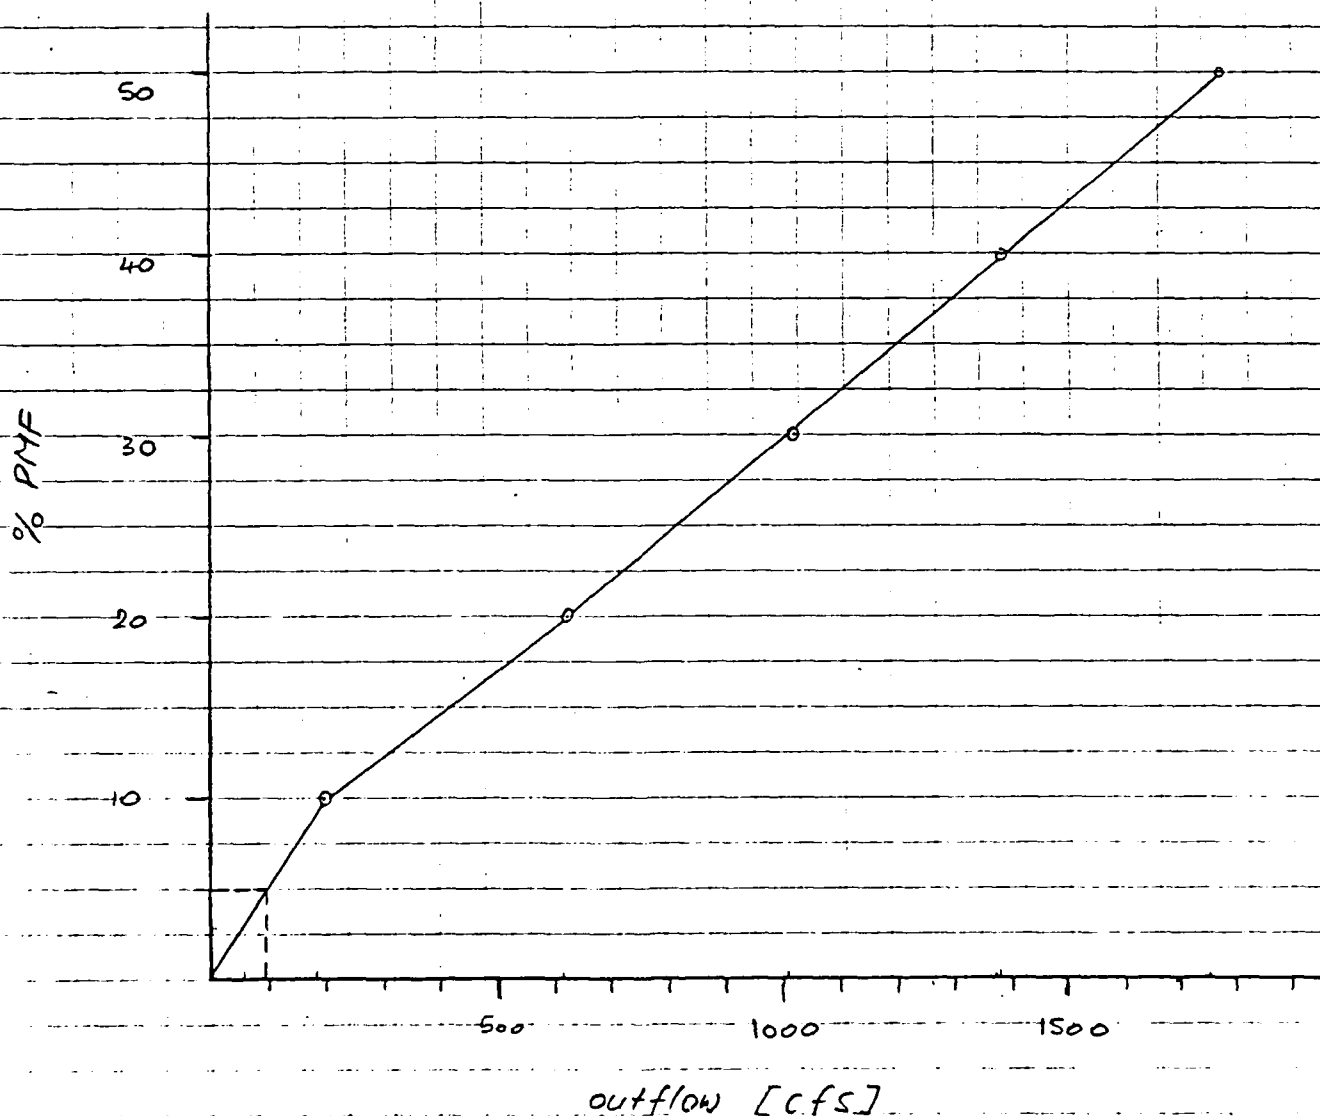
OVERTOPPING POTENTIAL:

OVERTOPPING OF DAM OCCURS AT ELEV. 962.25 [Ft]
WITH $Q = 96.6$ [cfs]. DAM CAN PASS APPROX.
5 % PMF
